## T34C CENTER BOARD REPAIR

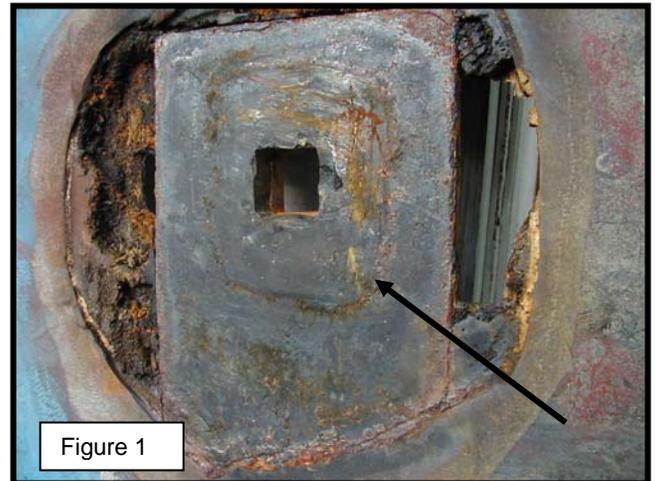
**The Fix:** I then attacked the board with the rotor tool that was set to a depth to remove the FRP from around the hole for about 8 inches in diameter. This was done on both sides (see figure 1). As is see in the picture, the board is constructed of a central steel plate about 6 inches wide,  $\frac{1}{2}$  thick and goes most of the length of the board. This steel blank is covered with FRP to give the eventual airfoil shape of the board. In the case of hull #57 the hole in the board that accepts the pin is a bronze or brass investment (see arrow) with what looked to be a diameter of 3-4 inches. Thus, the hard stainless pin was bearing on a relatively soft metal (brass or bronze) which was only  $\frac{1}{2}$  inch wide, a recipe for wear if I ever saw one. In a discussion with George Duffie, he told me that he had repaired his board by first adding material back to the hole and filling it back to the original square dimension. This he followed with welding  $\frac{1}{2}$  inch square bar stock around the perimeter of the hole to increase the thickness of the bearing surface to 1 inch. It is my guess that his board did not have the brass/bronze investment but was likely all steel.

When I took this remedy to my welder he suggested that we cut out the brass/bronze investment and replace it by welding in a 1 inch thick stainless steel donut with a square hole cut in the center dimensioned to fit the pin. This he did taking great care to not heat the steel blank so hot that it significantly charred the surrounding FRP (see Figures 2 & 3). The donut was position such that its flat surface was below the plane of the board so that when I re-constructed the FRP in this area (see below) the SS donut would be below the surface. Now it was time to repair the hole I had cut in the

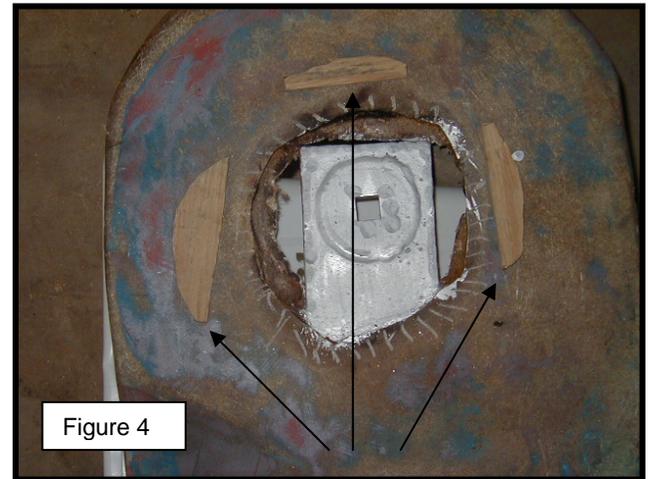
On sounding the board with a plastic hammer, I found a number of voids. Some were near the hole that I cut and were probably a result of the core material burning out during the welding. Others were further away and likely due to original poor lay up. I fixed these by drilling multiple 1/8<sup>th</sup> inch holes in the area of the voids and injecting slightly thickened epoxy resin until it oozed out of all holes. As each hole began to ooze I plugged it and continued until all holes were oozing. At the same time I repaired some dings in the leading and trailing edges of the board.
