Recoring around Stanchion Bases

Nut Case was purchased with the knowledge that port and starboard sides had issues surrounding the stanchion bases. Water intrusion and deck rot was suspected. Below is a picture of the area on the day delivery was taken of the boat. Pilot holes were drilled and revealed that the water in the core extended only a few inches each side of the stanchions. The fix was to remove the old core, replace with new material and fair and paint the area. The series of pictures below demonstrates the process.

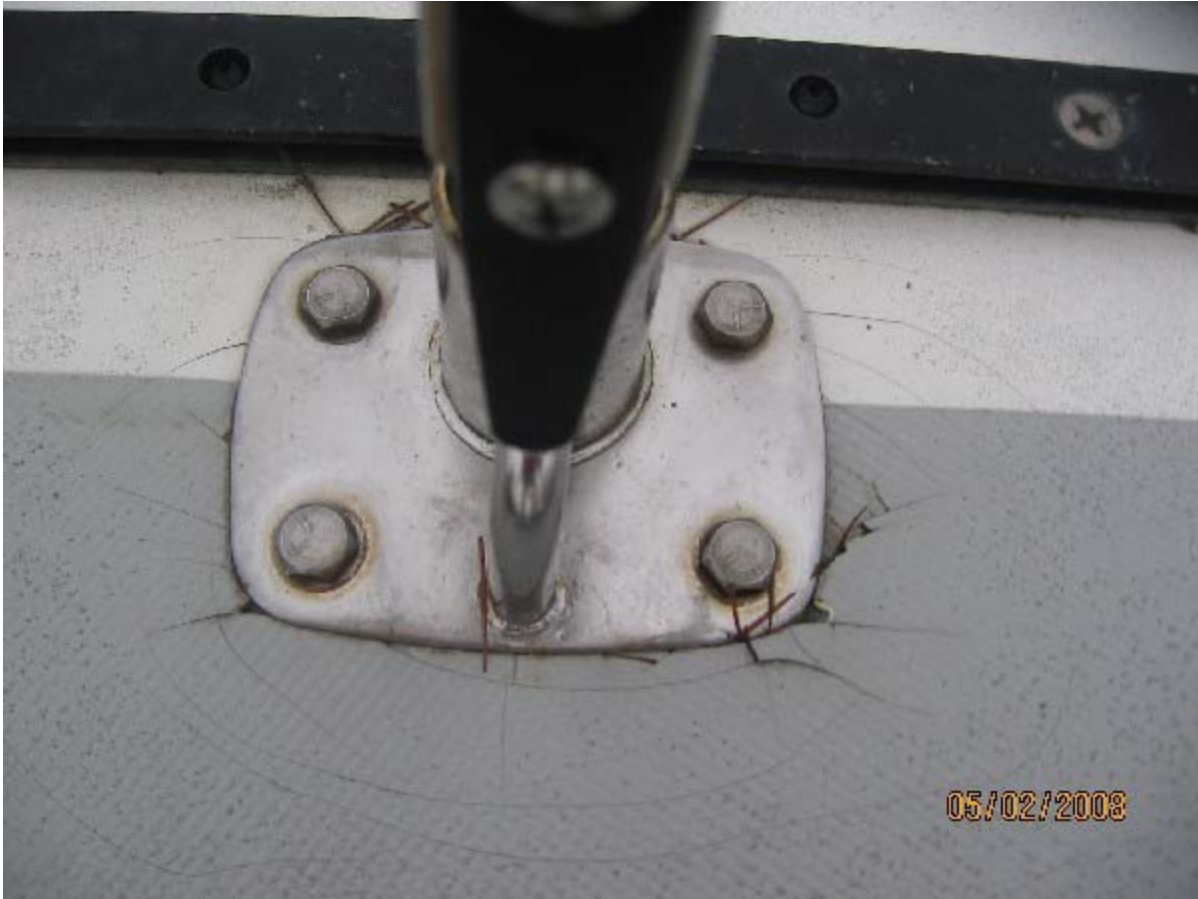
Surface of deck is cracked. Water oozes out.

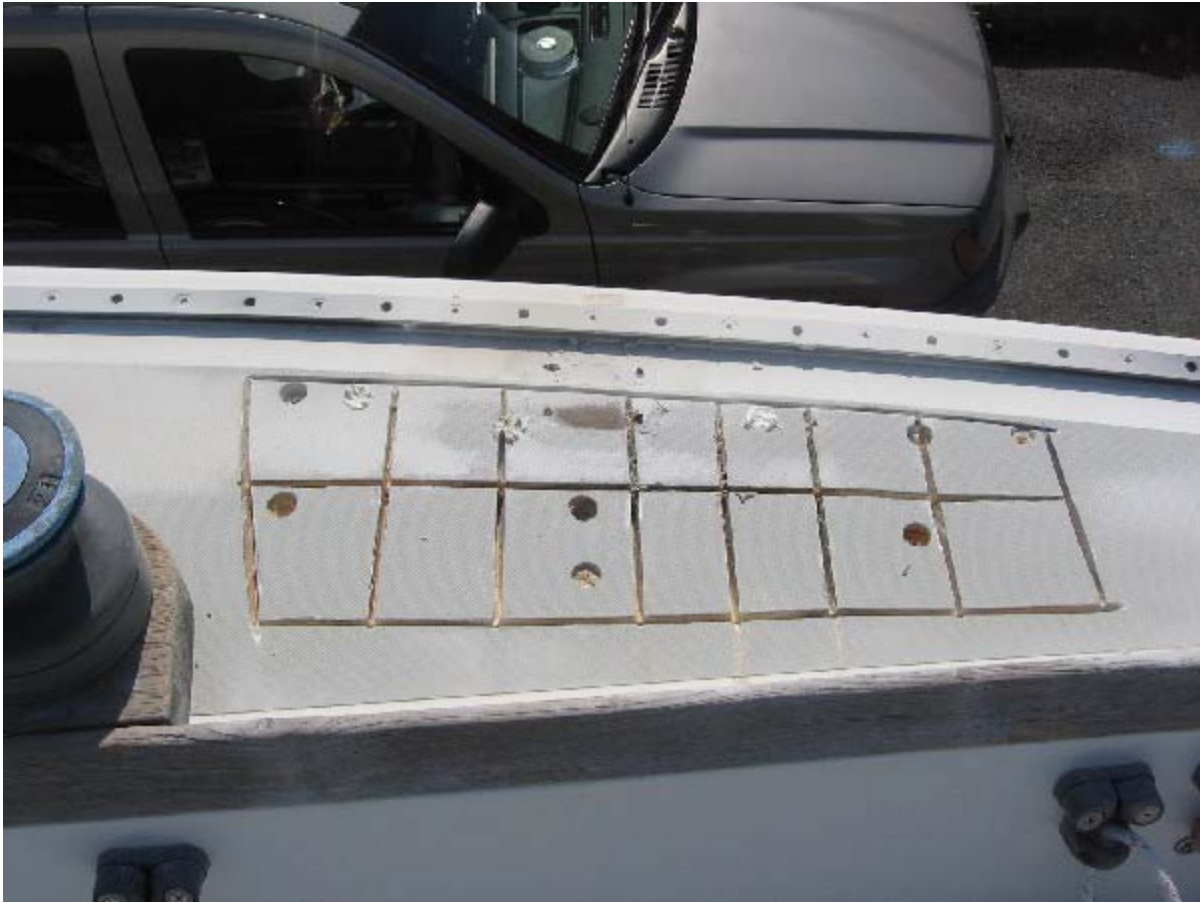
Stanchion removed and a hatch pattern cut to facilitate removal of old core. Cuts using a 4.5 inch angle grinder

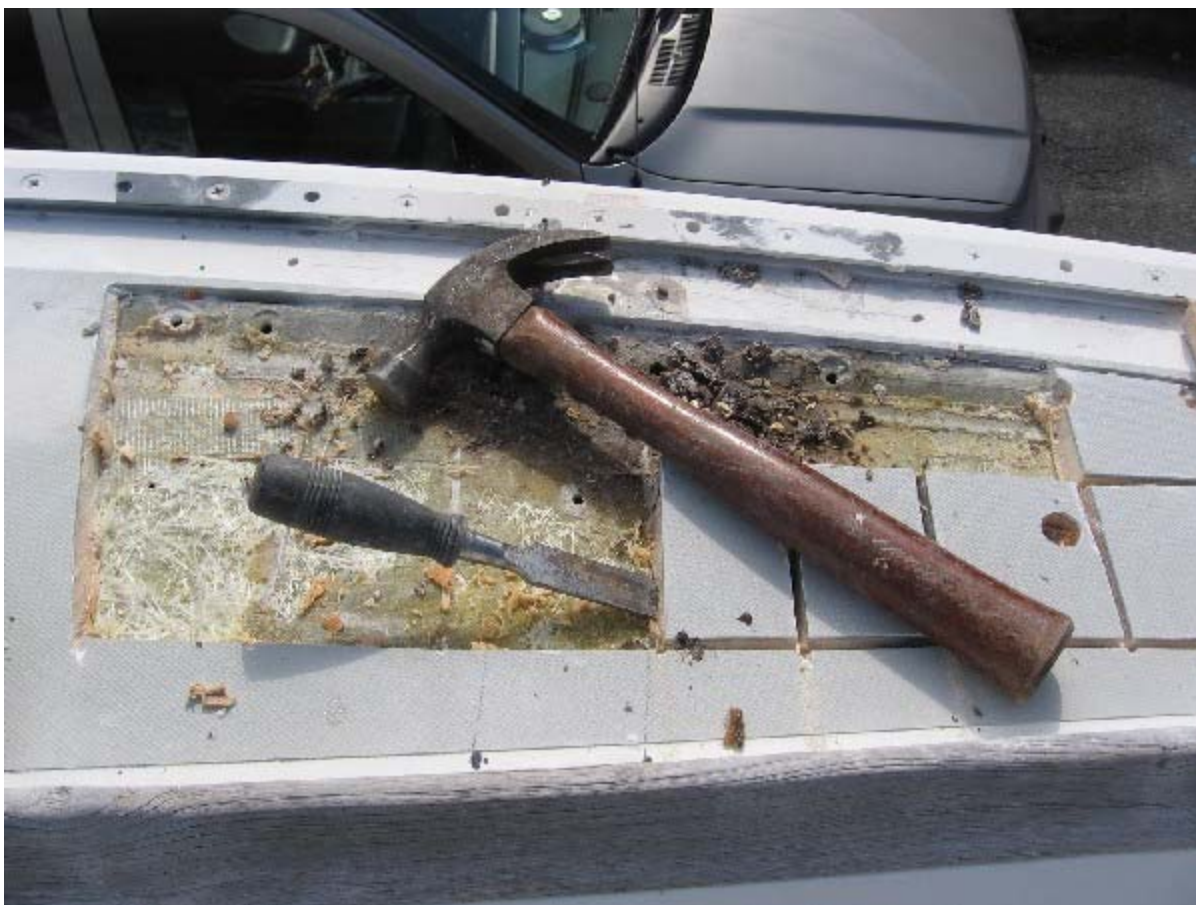
Removal of old core. Using wood chisel and hammer.

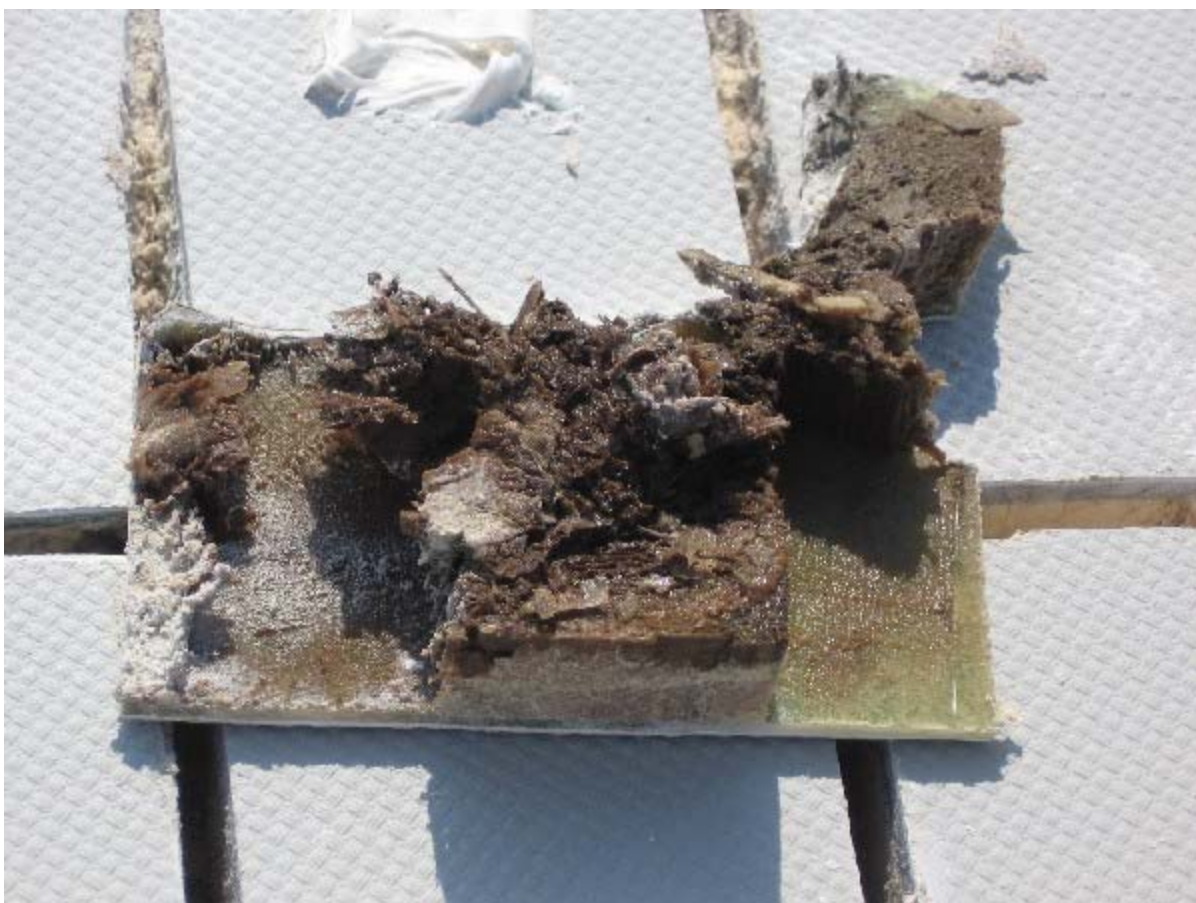
This is what rot looks like in a deck

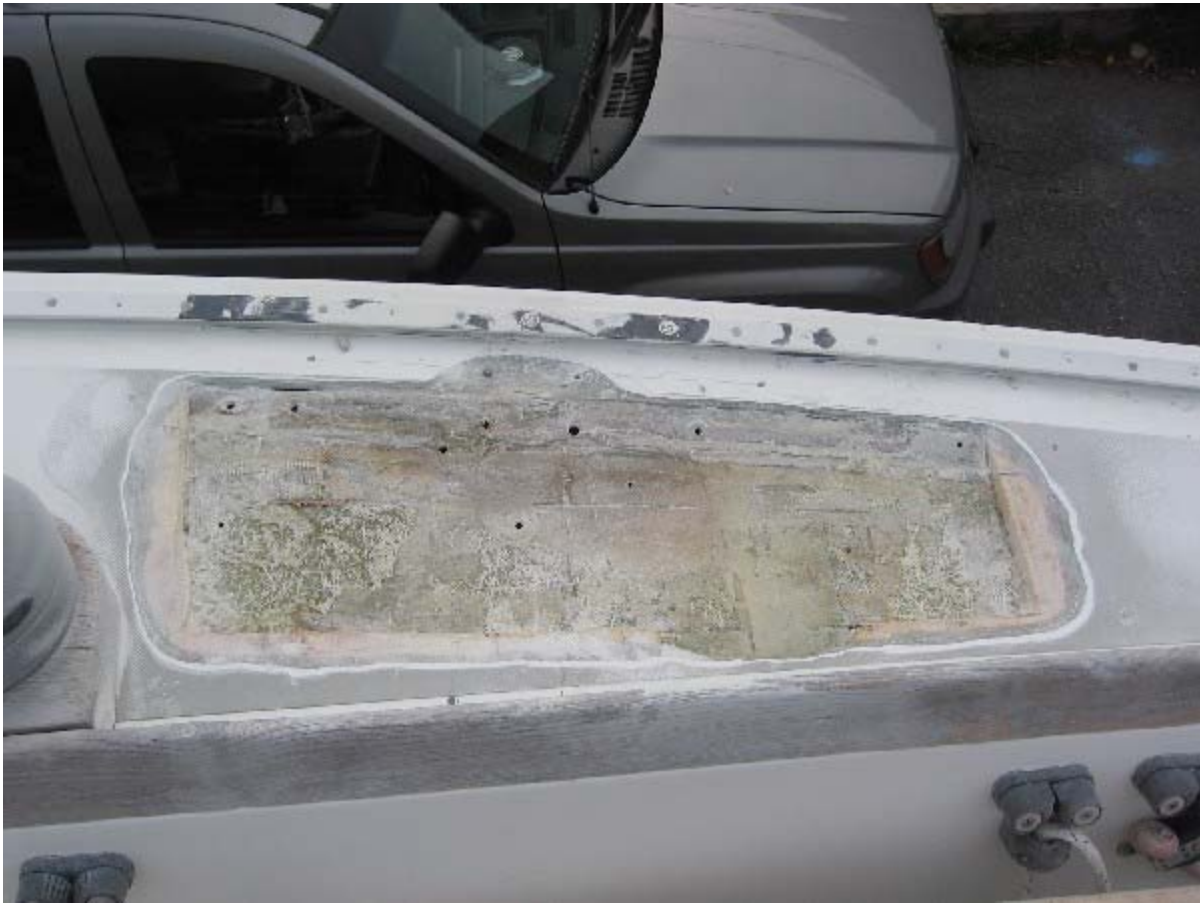
Old core removed, edges tapered and ready for cloth, mat, cloth and core material

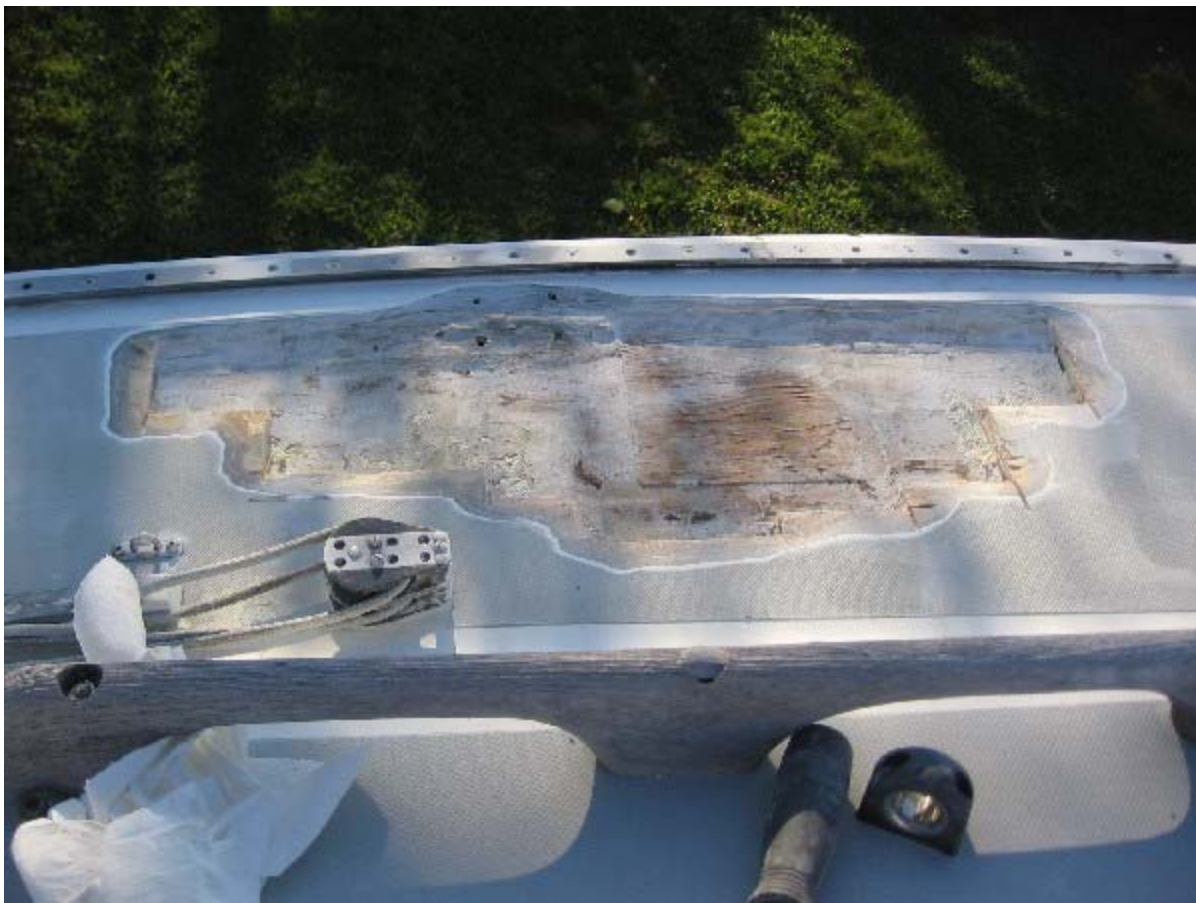
Port forward stanchion area - core removed and edges beveled - ready for recore.

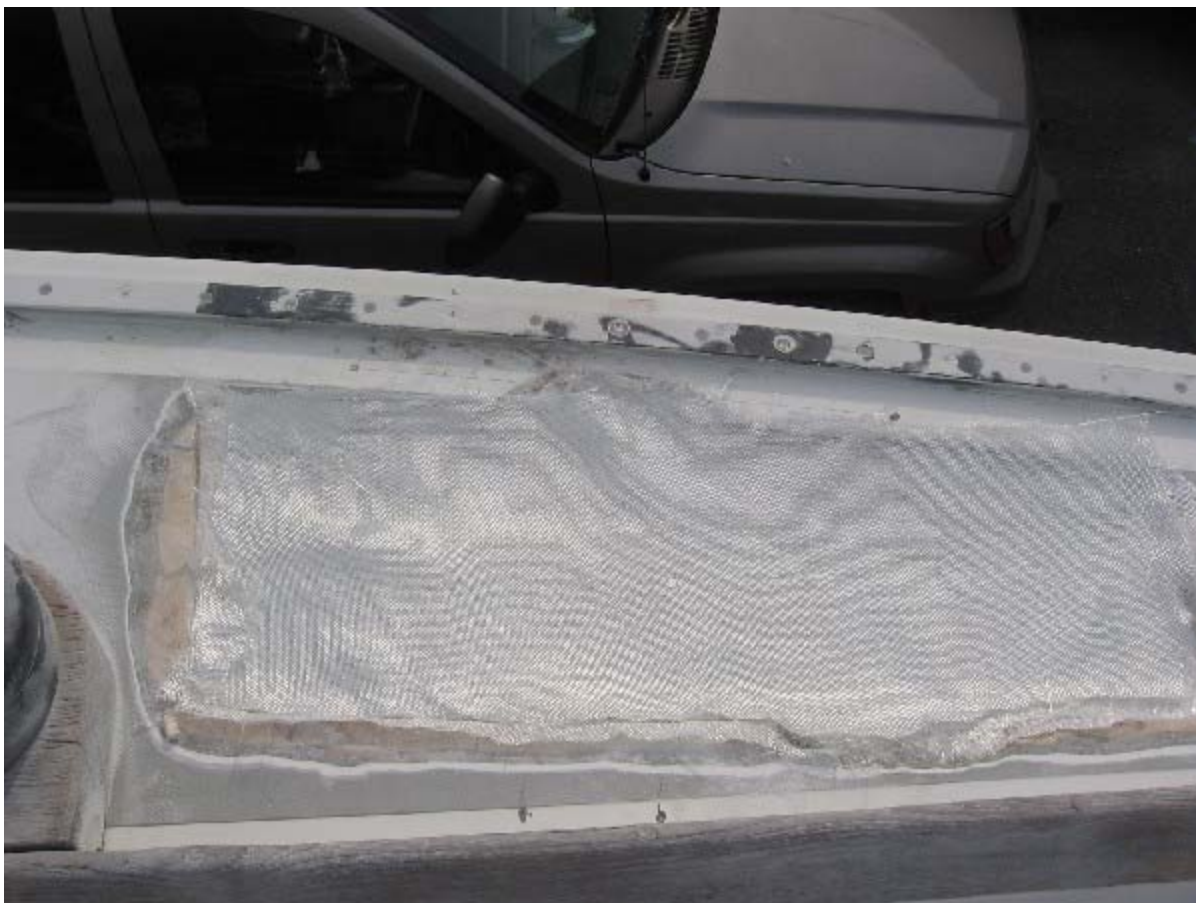
Cloth in place and ready for core material.

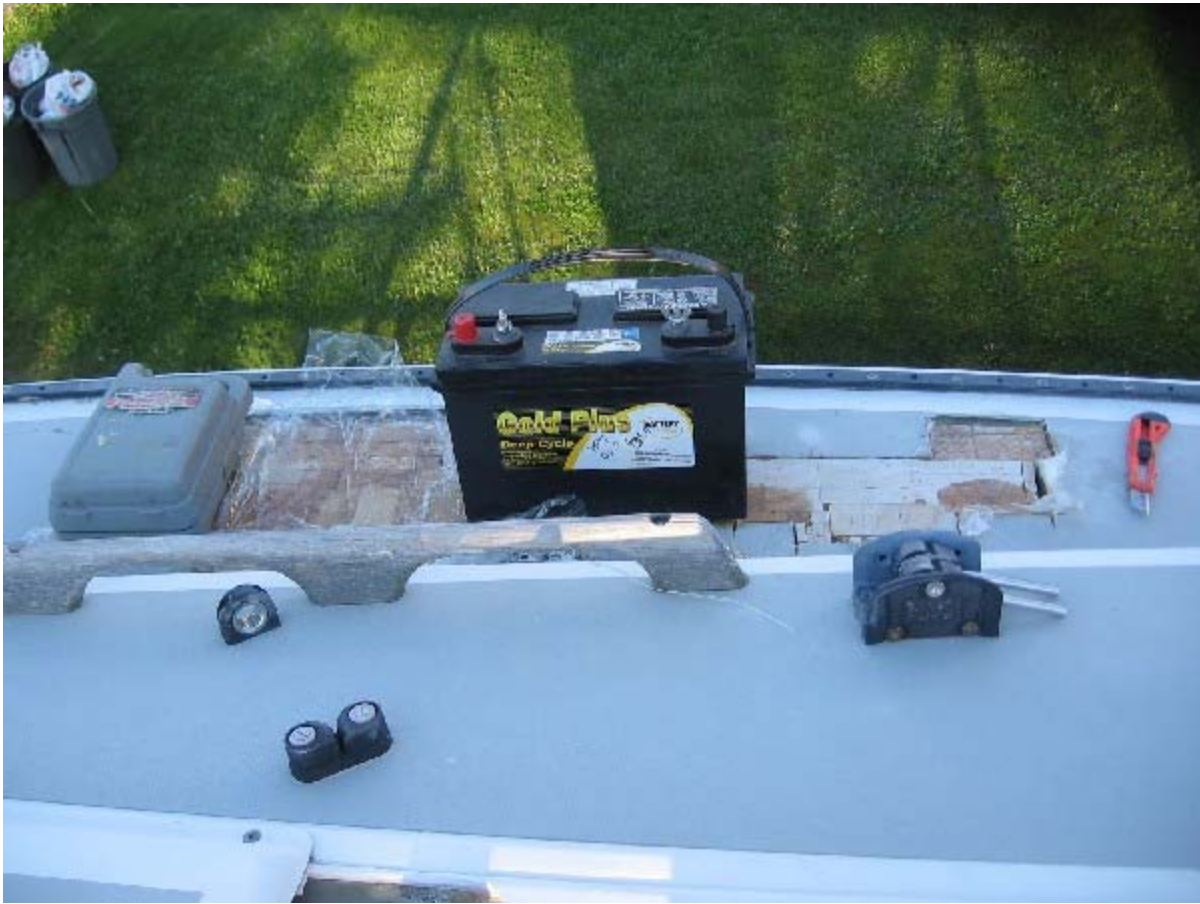
Stbd forward stanchion area. Weighting down the core material while resin cures. Plastic food wrap will not adhere to epoxy and prevents weights from adhering to core material.

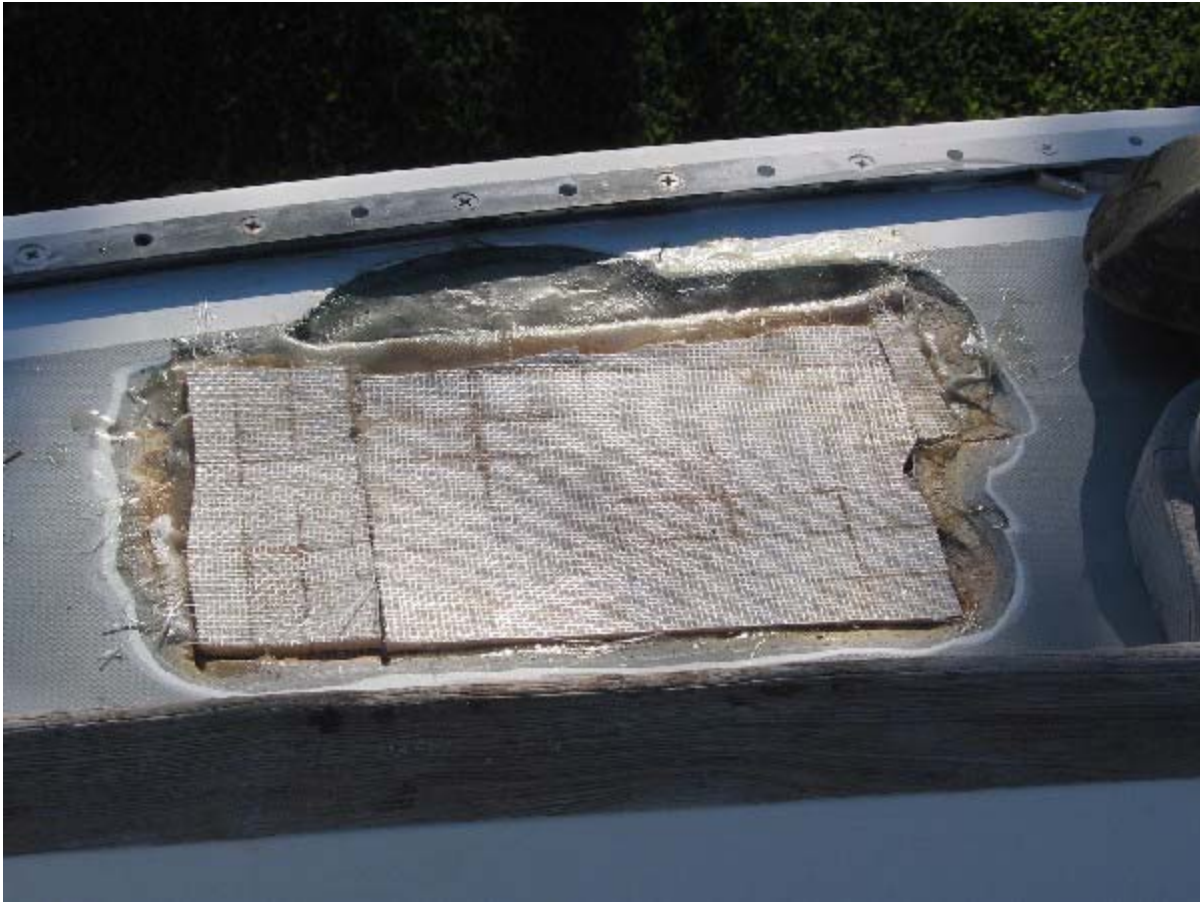
Core Material Epoxied in place in the second area.

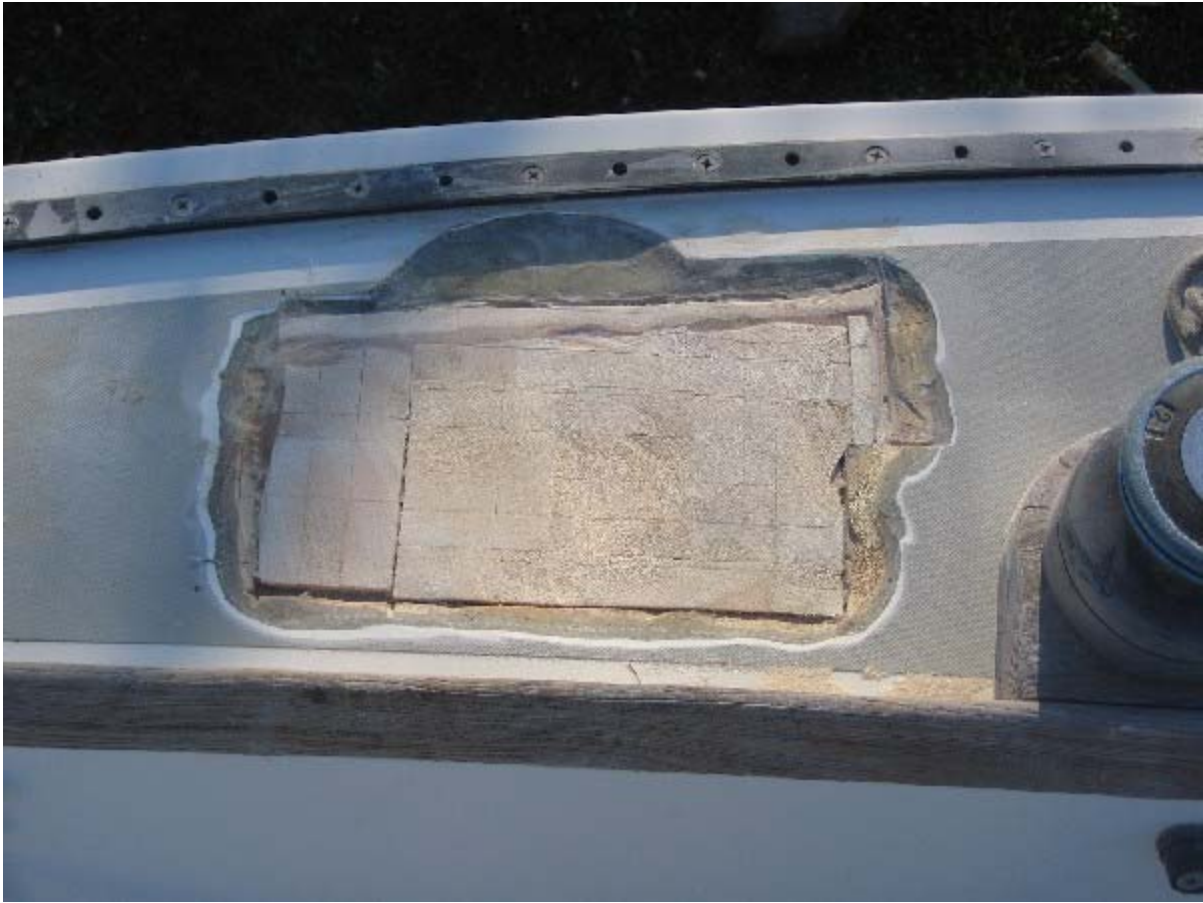
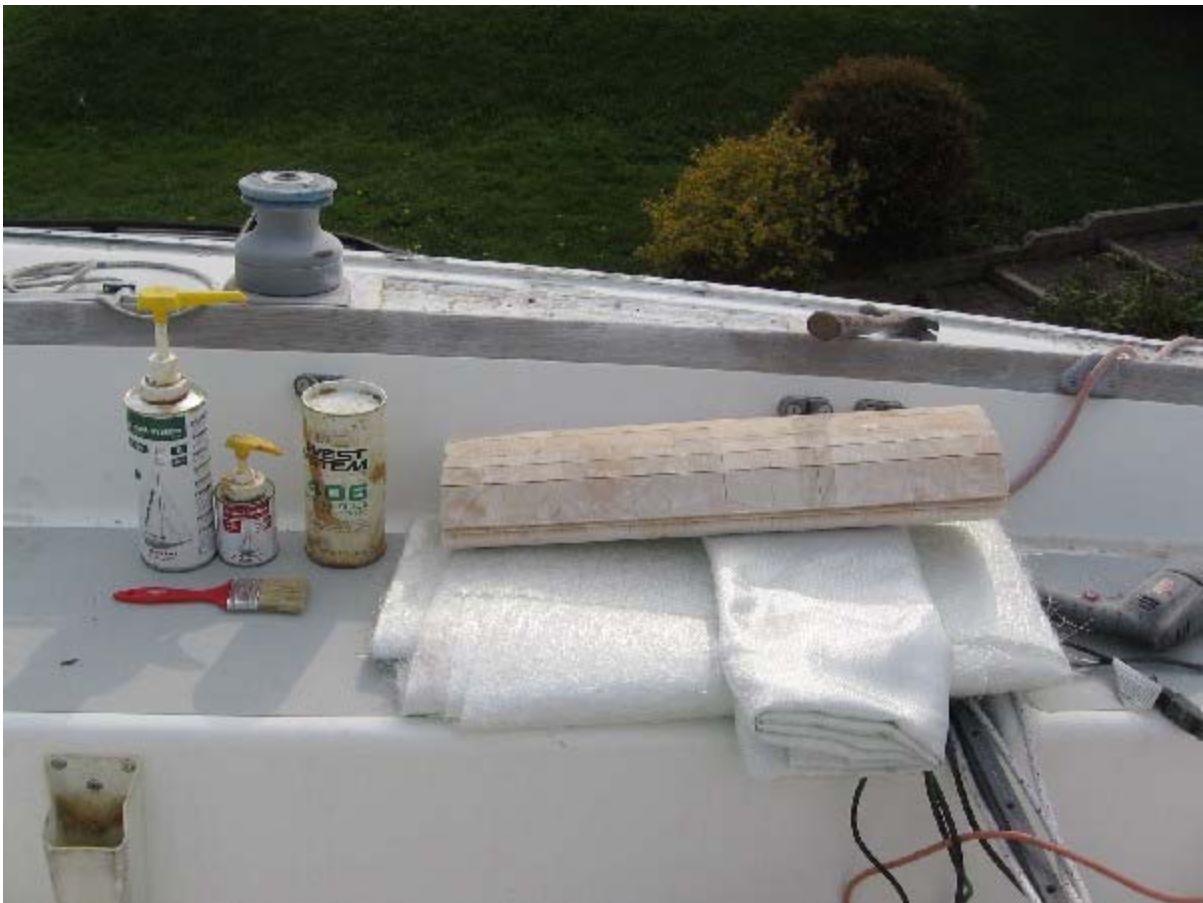
Below - after grinding core material. Ready for next layers of cloth

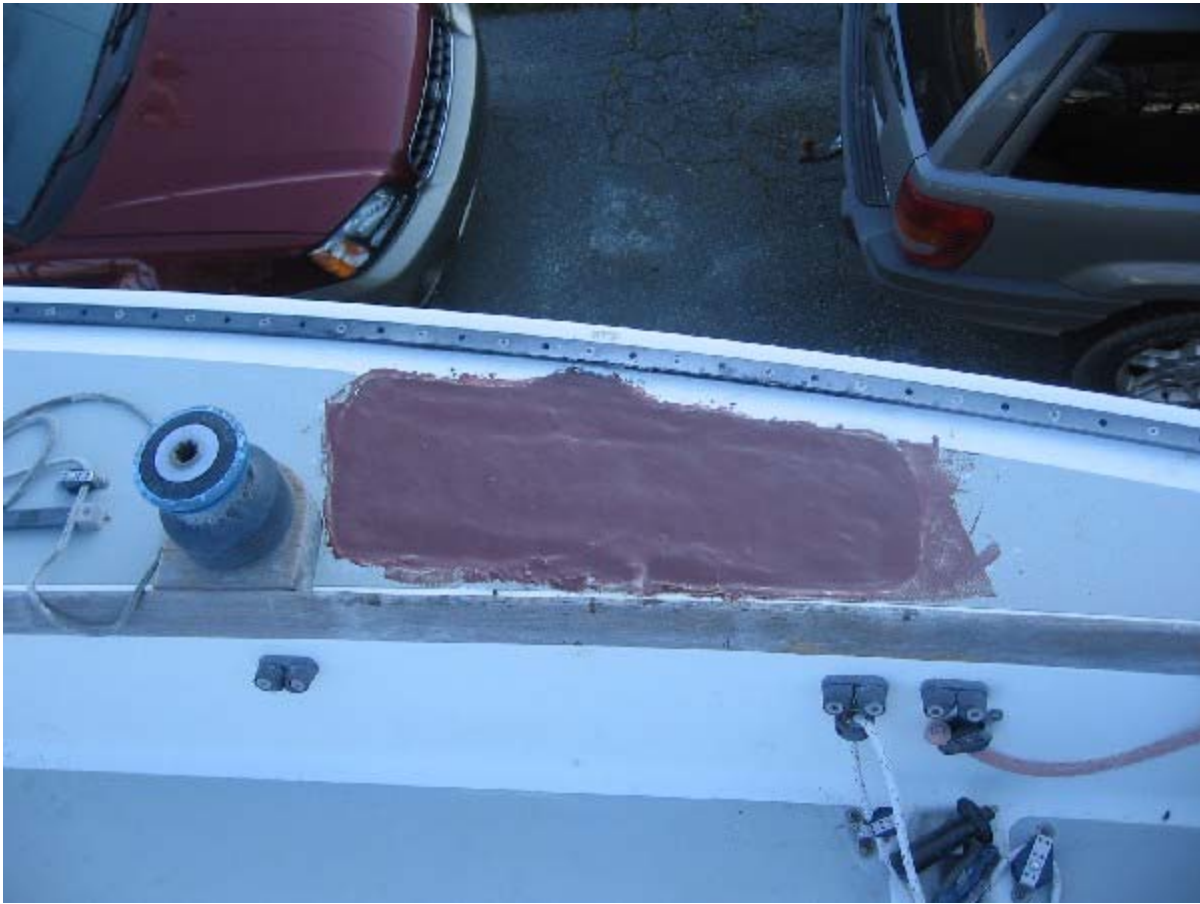
First leveling coat applied. East System epoxy with West 407 sandable filler

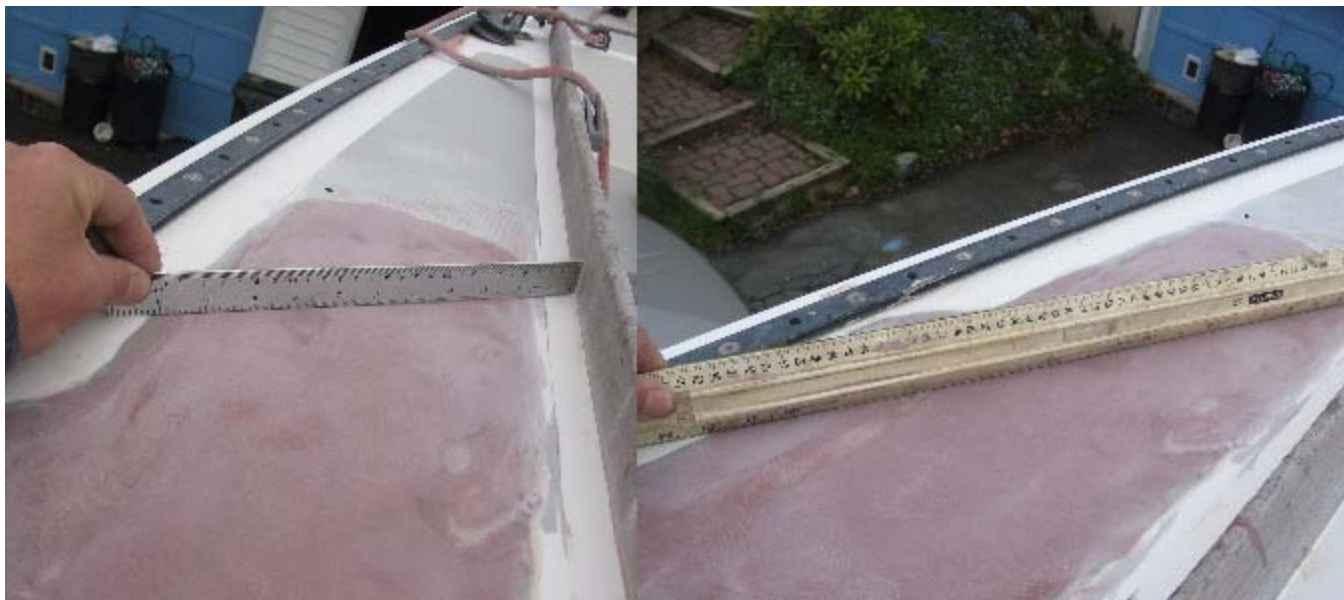
Checking for high spots

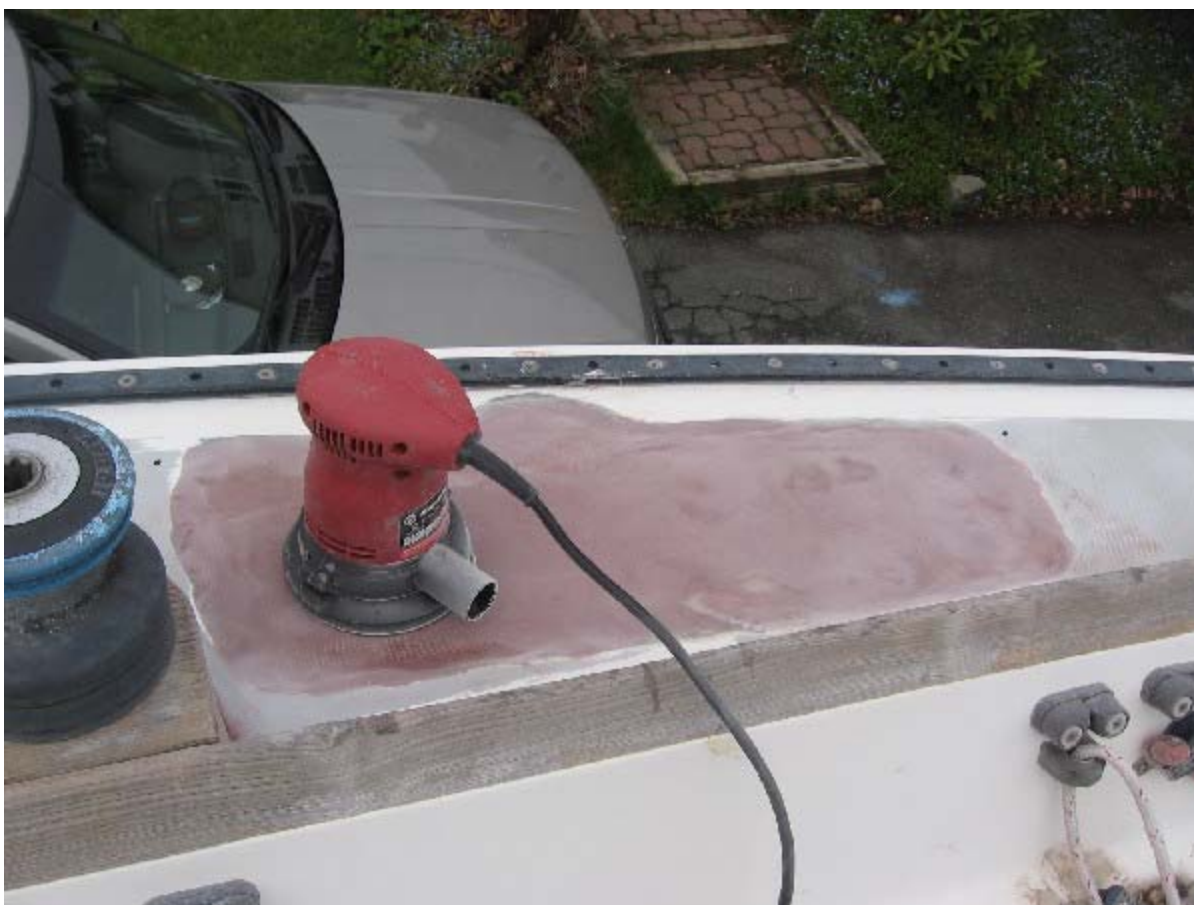
Sanding the high spots using 80 grit and Random Orbital Sander

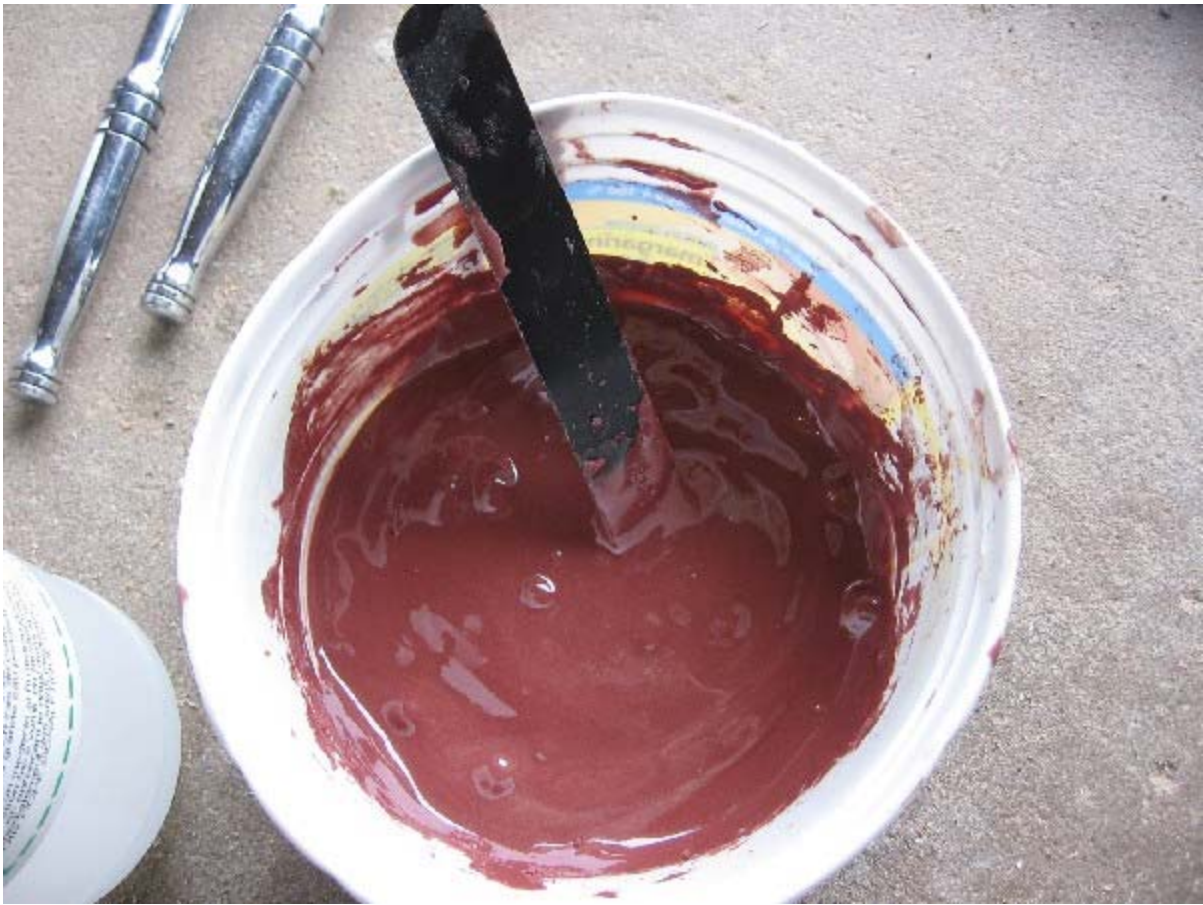
Epoxy mixed with Sandable Filler for skim coat

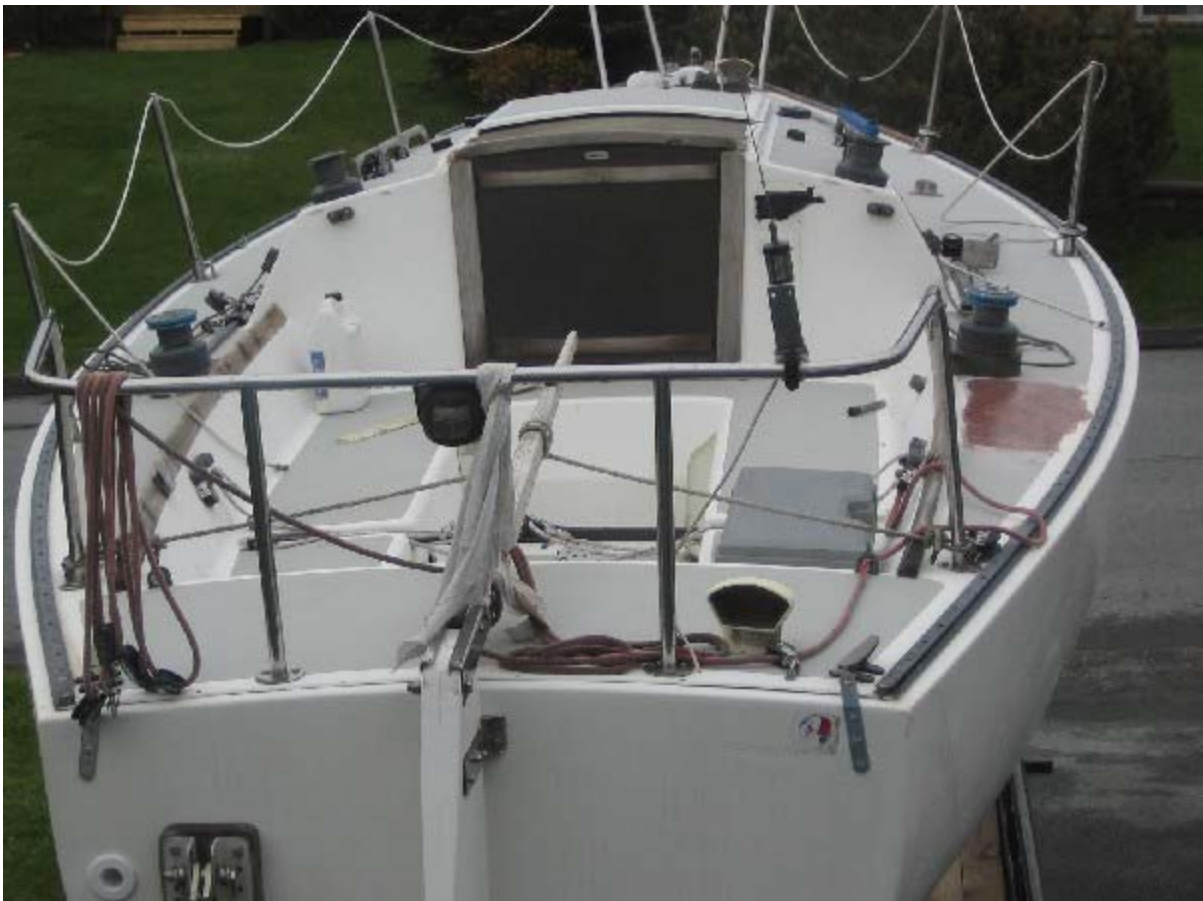
From astern - after first skim coat applied

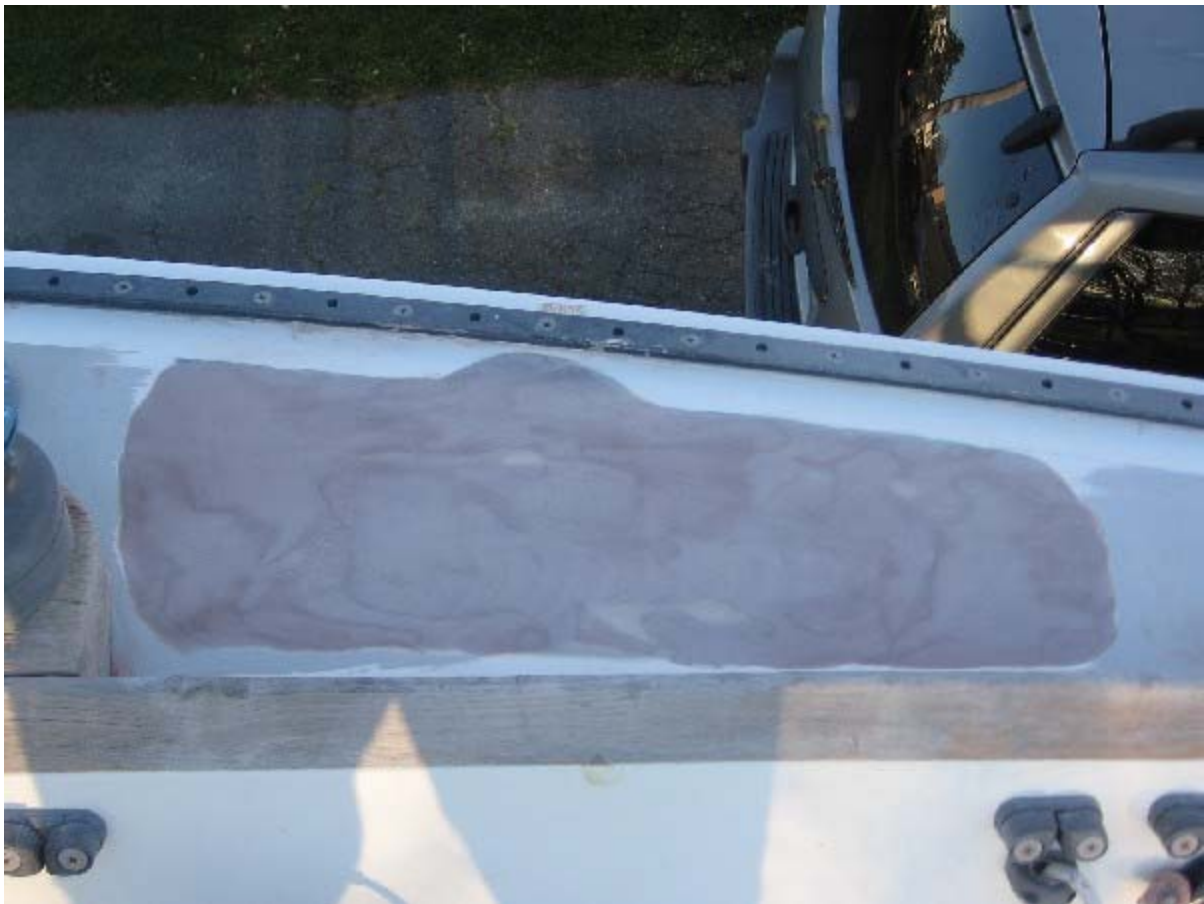
Port aft - ready for primer & paint

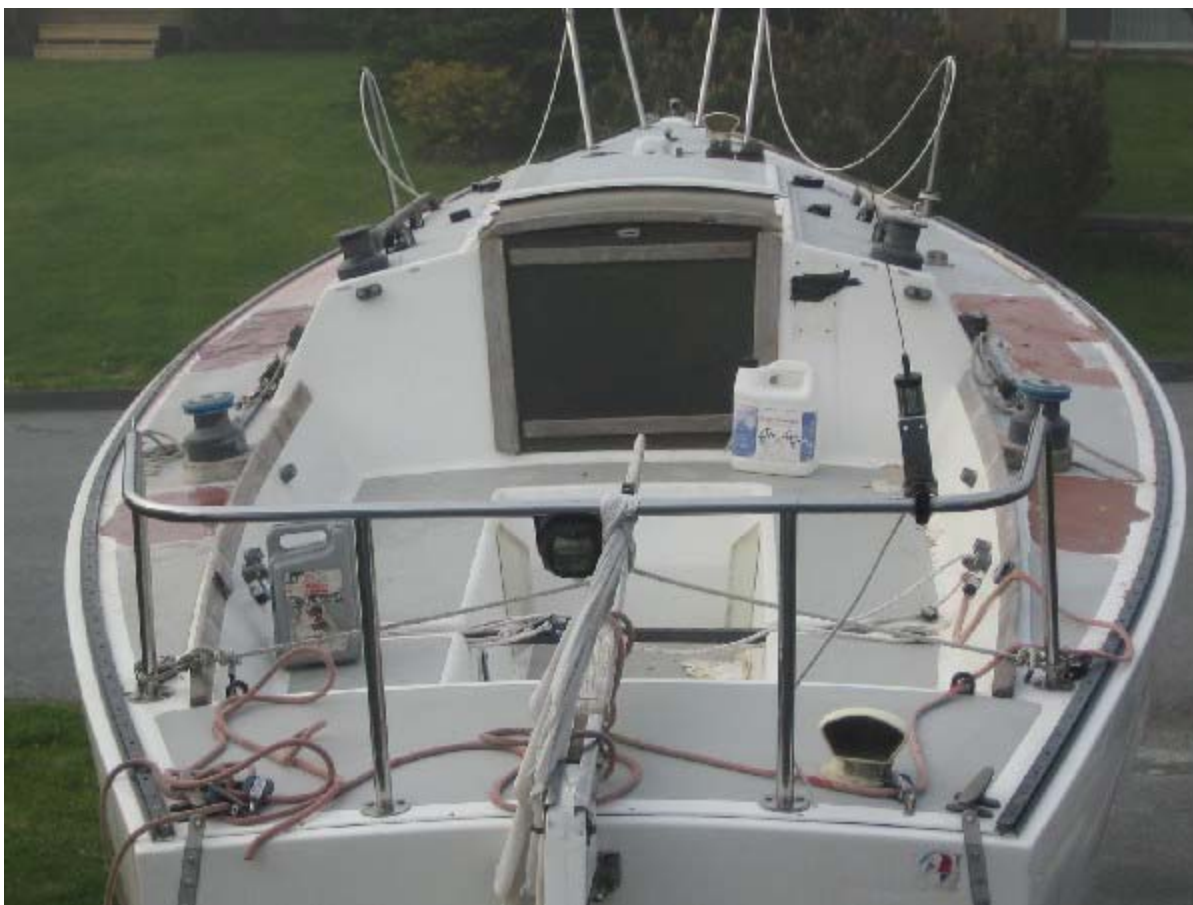
All four sections now recored and fairing coats applied

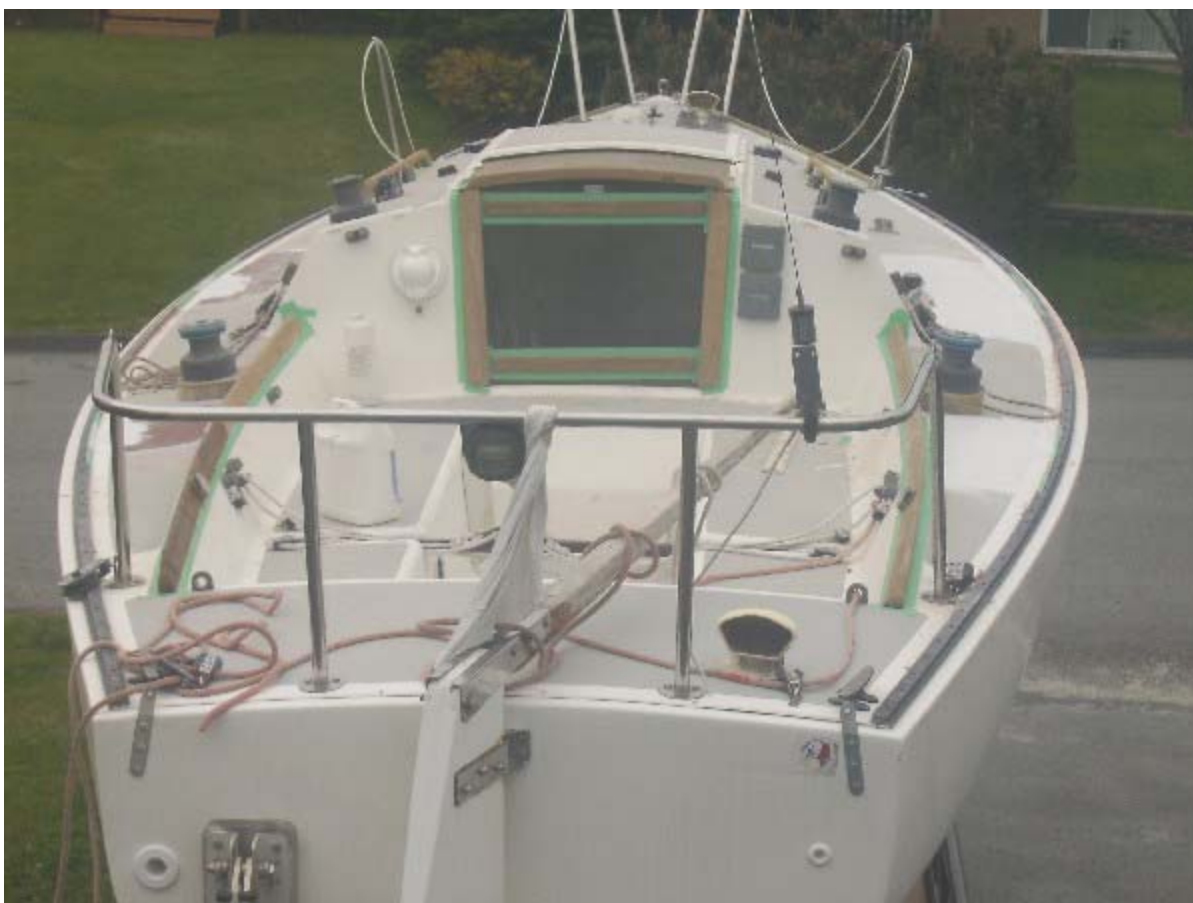
Fairing Complete. Stbd sections primed with Interlux Pre-Cote. Instruments and compass installed.

Exterior teak sanded and taped

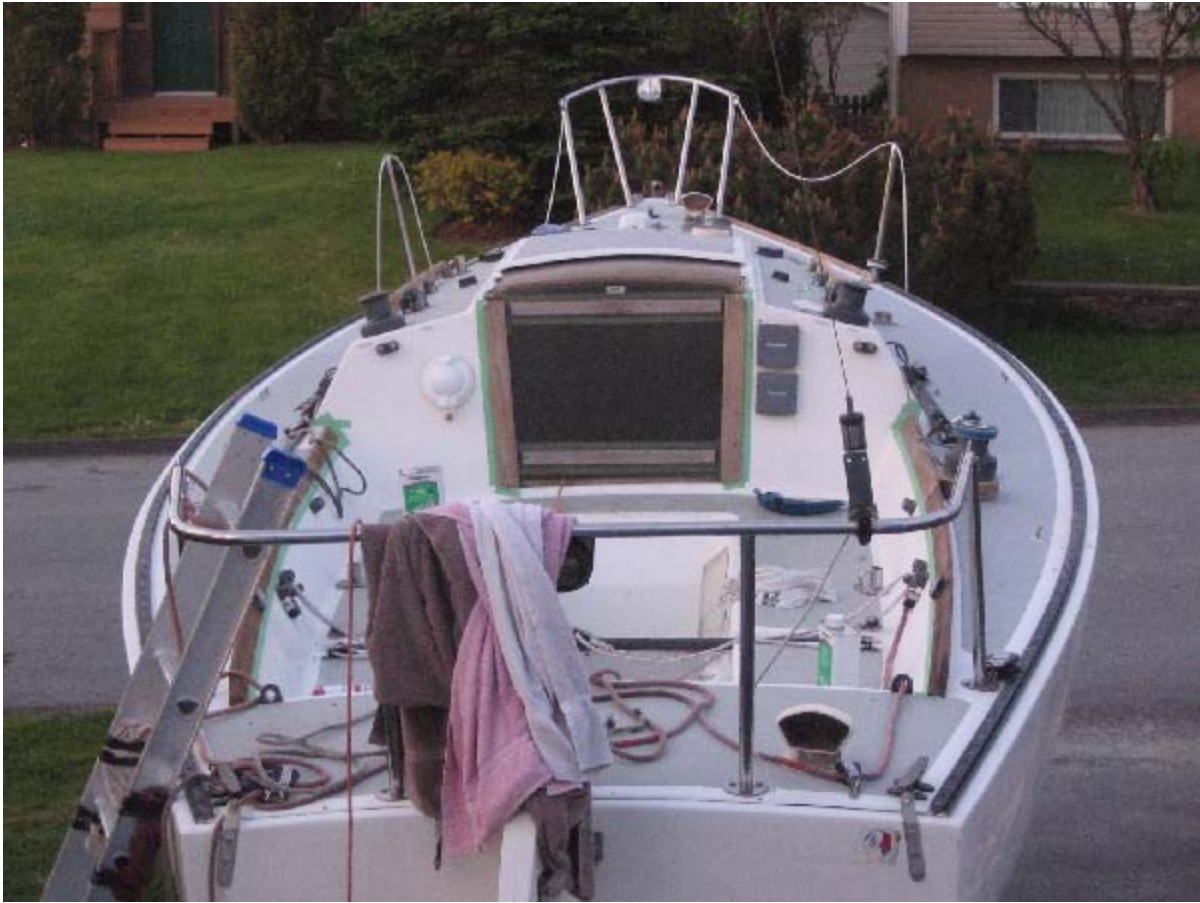
Painted with Interlux Interdeck grey. Entire side deck non skid painted for consistency.

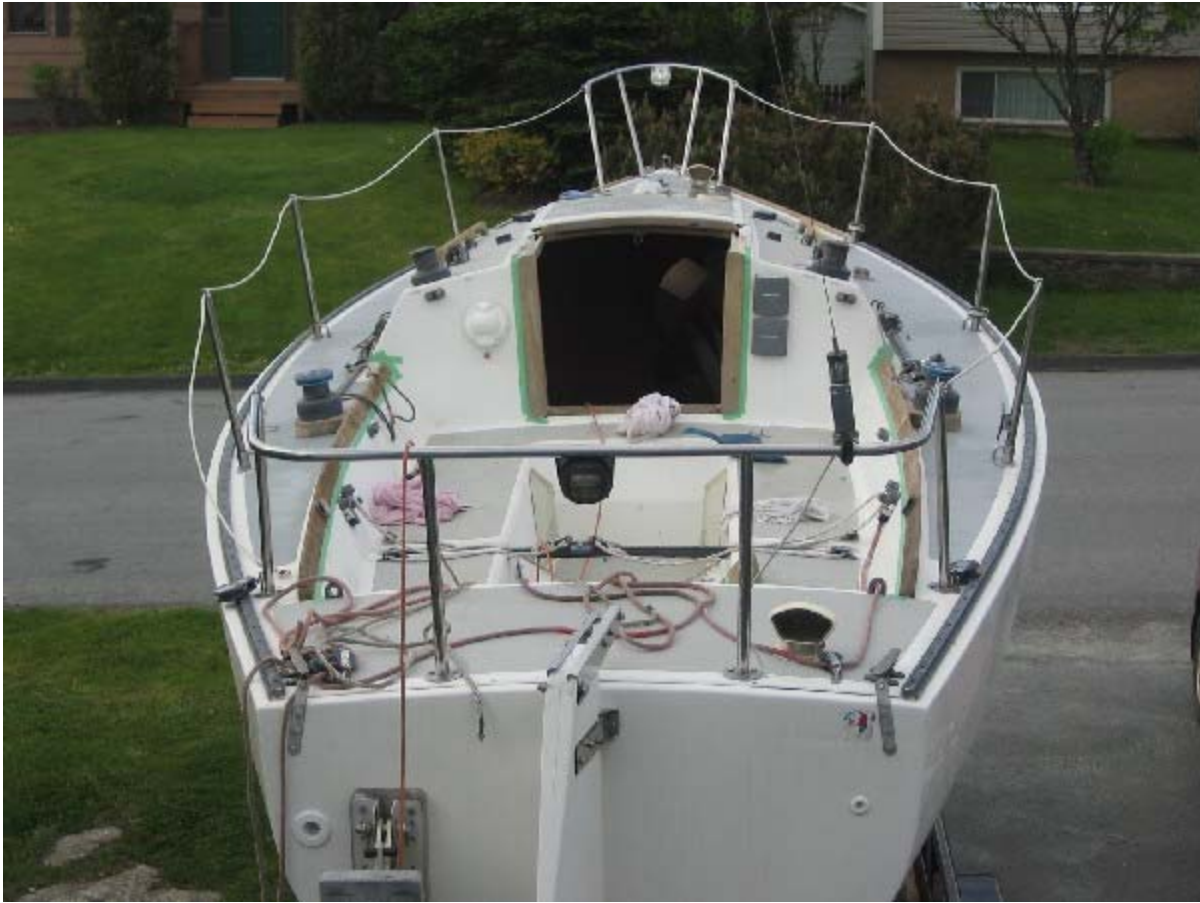
Job Complete with stanchions rebedded. Forgot what a pain that was!
