## T34C CENTER BOARD REPAIR

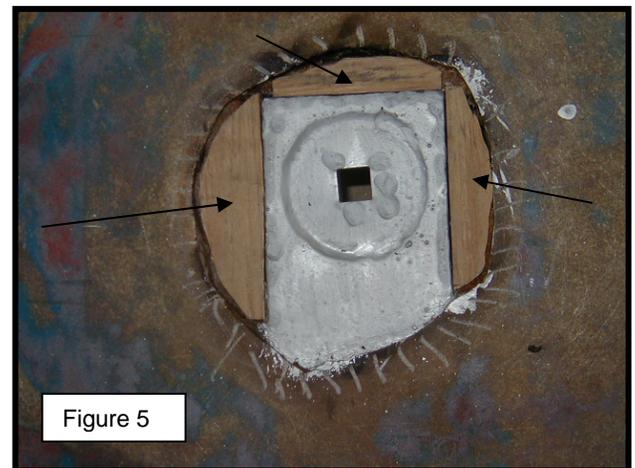
**NB:** One cautionary tale is to be aware that there is a bushing on the port side of the CB trunk that accepts the small end of the CB pin. At least in my case this bushing was not secured and some time during the period between the removal of the board and it's reinstalling it dropped out and disappeared (did I tell you that I sailed for a whole season without the board while I fixed it?). The unfortunate aspect of this is that it is not a standard size bushing either in the outside or inside diameters. As a result I had to have one custom made. Not expensive (\$40) but a pain in the butt because the ID of the hole that receives the bushing is difficult to measure so I gave it the best I could. Well you know it was over sized so I spent a lot of time filing it down to fit. Once it fit I cut grooves around the diameter then bushing was epoxyed in place by lathering the hole in the CB trunk and the outside of the bushing with thickened epoxy then using the pin to locate it into the hole. The pin was generously covered with wax and mold release so that the bushing and pin would come apart after the epoxy had kicked. In my frenzy to get this all back together I forgot to measure the final OD of the bushing, for this I apologize.
